Inspection Tech Home Inspection Report

Mr. & Mrs. Client

1234 Example Dr.

Inspected on Tue, Oct 2 2018 at 10:44 AM

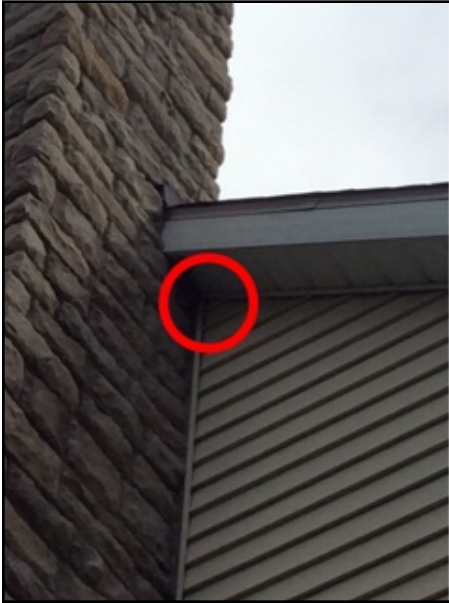
Figure 1-1

Insect nest present near chimney chase. Recommend removal.

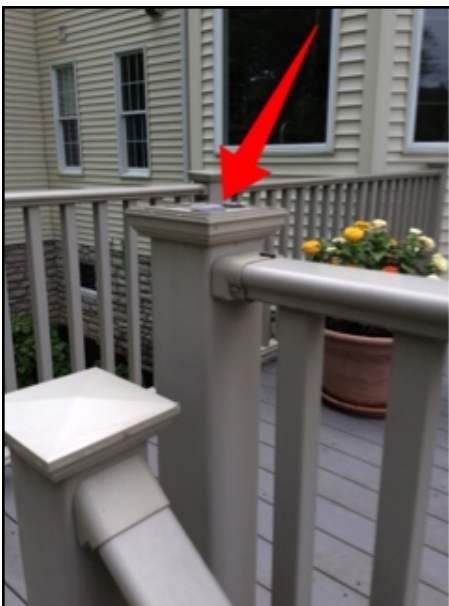
Figure 2-1

Missing cap for handrail post. Recommend repair.

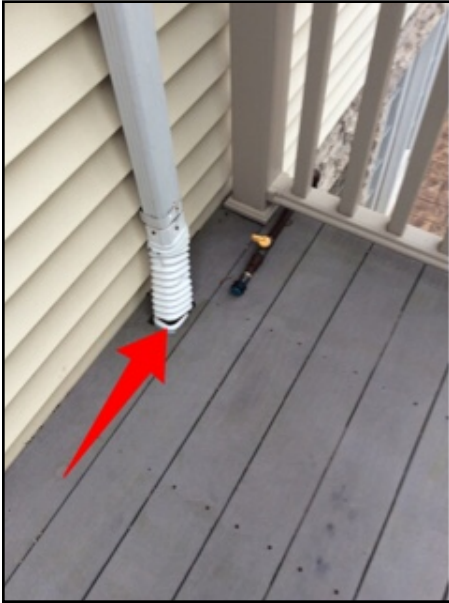
Figure 3-1

Damaged piece at rear gutter. Recommend repair.

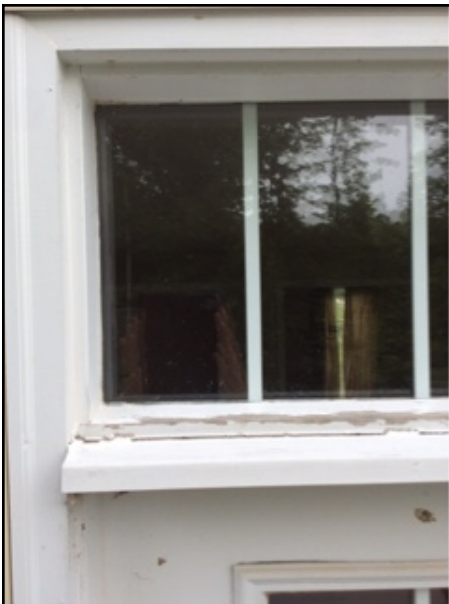
Figure 4-1

Wood trim needs paint. Recommend repair.

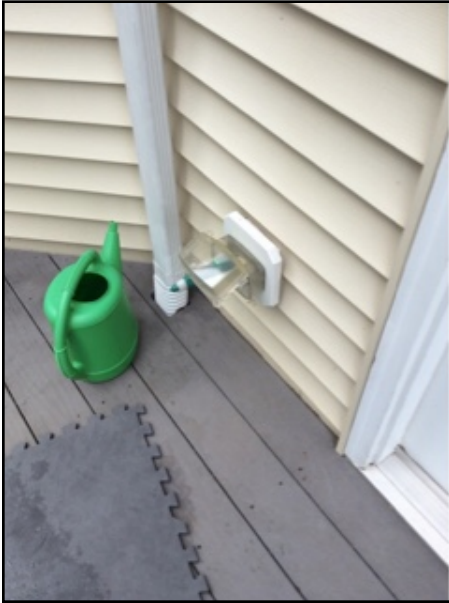
Figure 5-1

Comment 5:
GFCI outlet does not trip. Recommend replace. Safety Hazard.

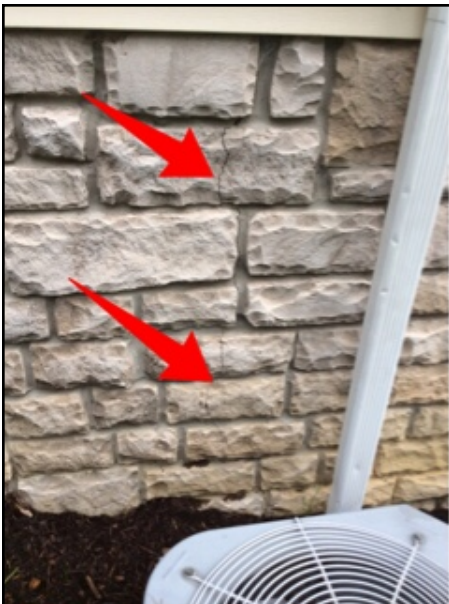
Figure 6-1

Comment 6:
Recommend sealing settling crack. Recommend repair.

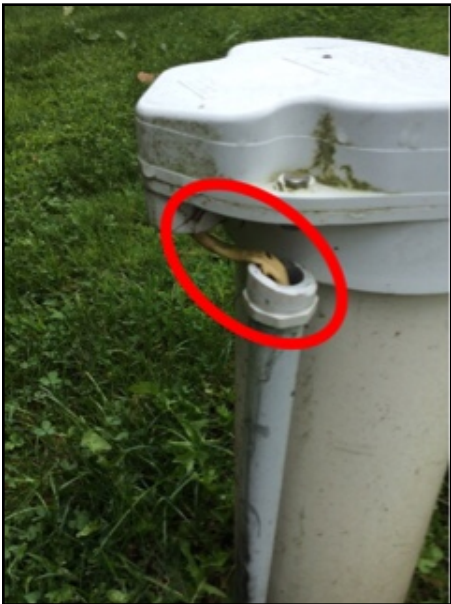
Figure 7-1

Comment 7:
Conduit and wire at well head were damaged. Recommend repair.

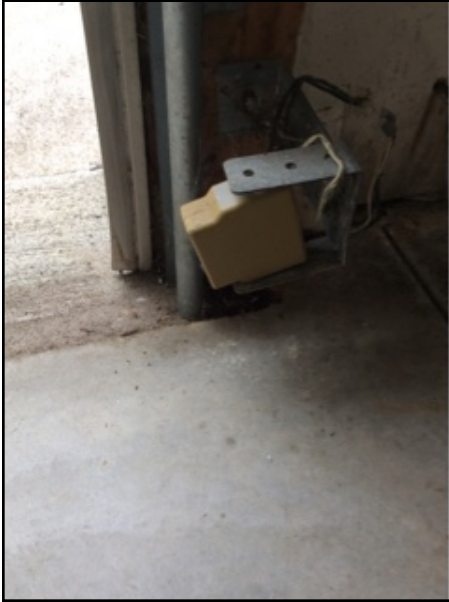
Figure 8-1

Garage door was not shutting properly with button. Button had to be held down to shut door. Recommend repair.

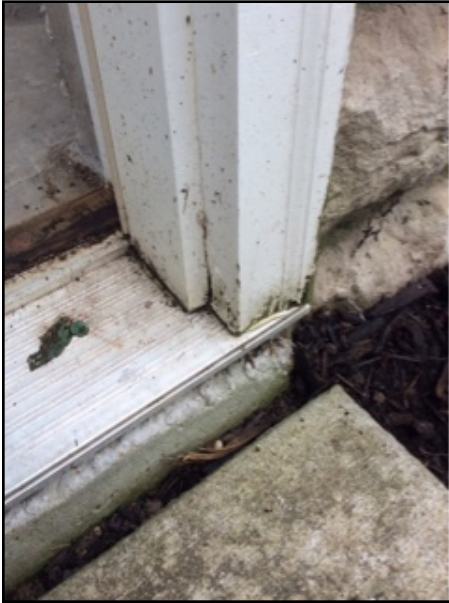
Figure 9-1

Wood trim at garage is rotted. Recommend repair.

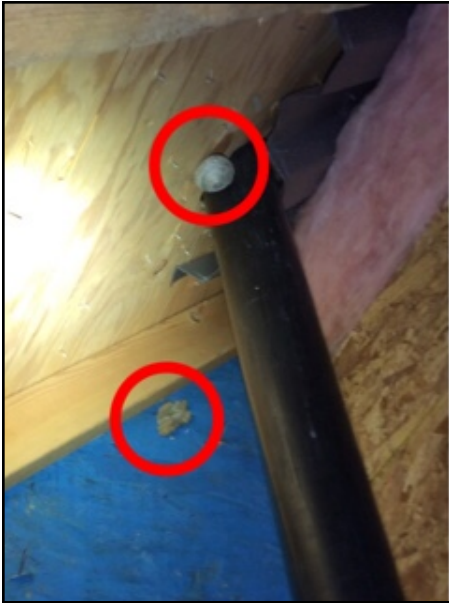
Figure 10-1

**Comment 10:**
Old insect nests in attic space. Recommend routine pest management.

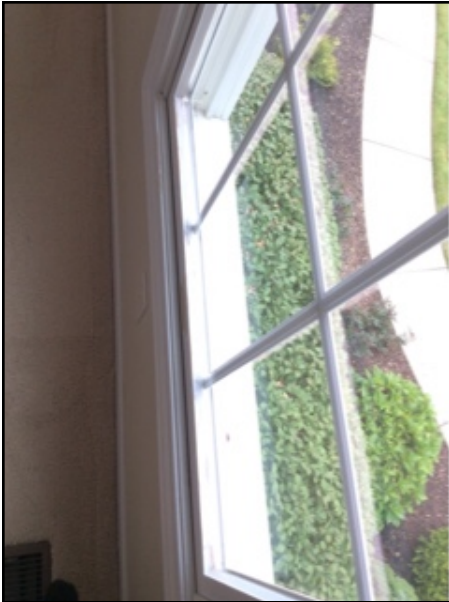
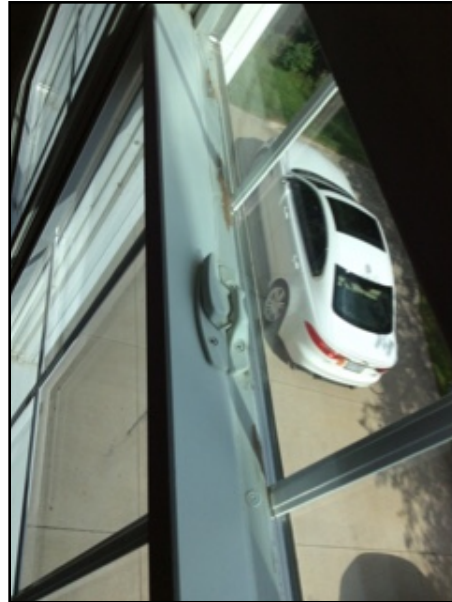
Flaking paint at multiple wooden window frames. Not all instances pictured.
Recommend repair.

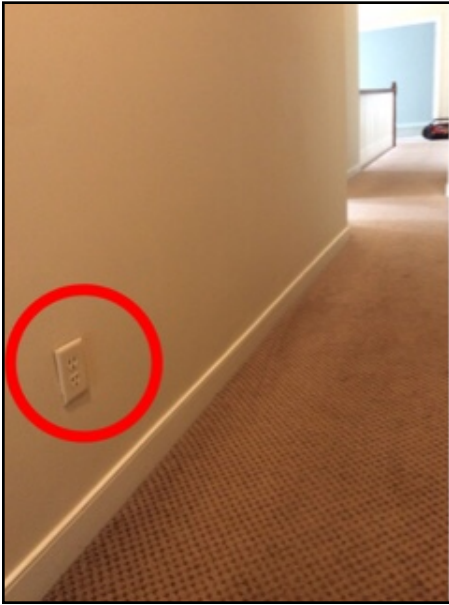
Figure 12-1

Several loose electrical outlets throughout the house. Safety Hazard. Recommend
repair.

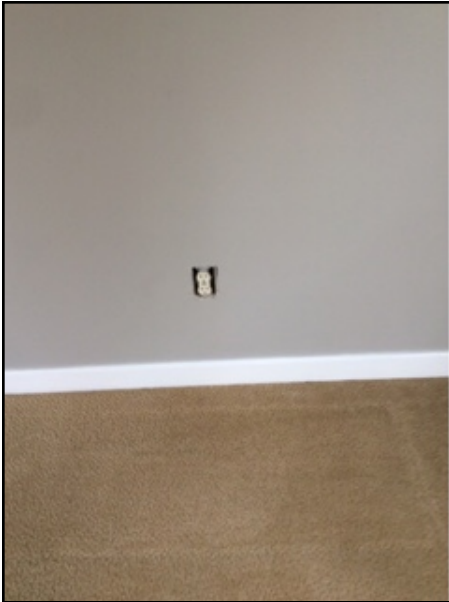
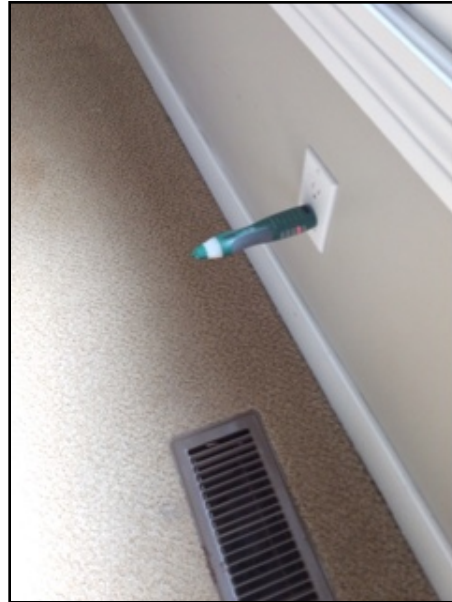
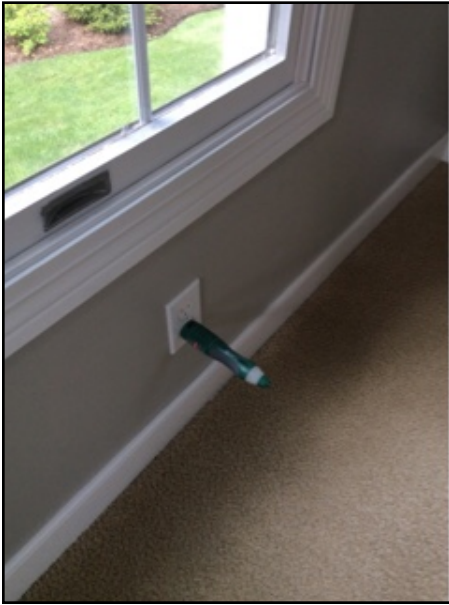
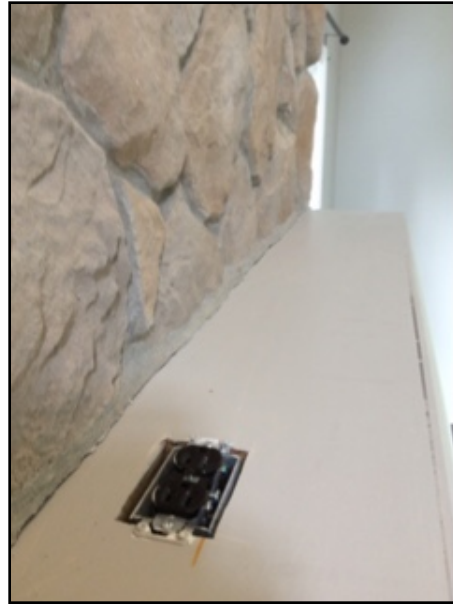
Missing outlet cover. Ungrounded outlet. Hot/neutral reversal. Safety hazard.
Recommend repair.

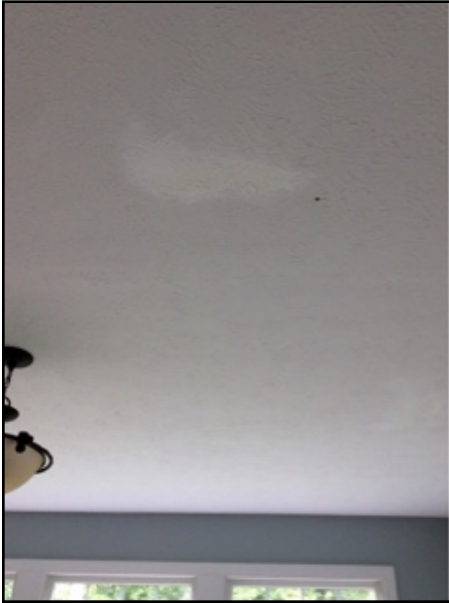
Figure 14-1

For Information: Previous repairs at ceiling.

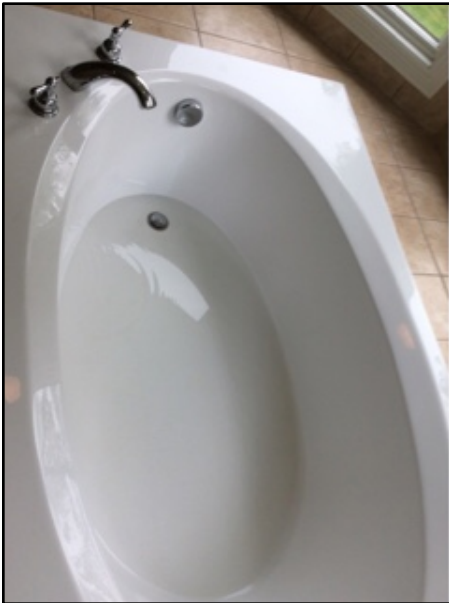
Figure 15-1

Comment 15:
Slow drain at bathtub. Recommend repair.

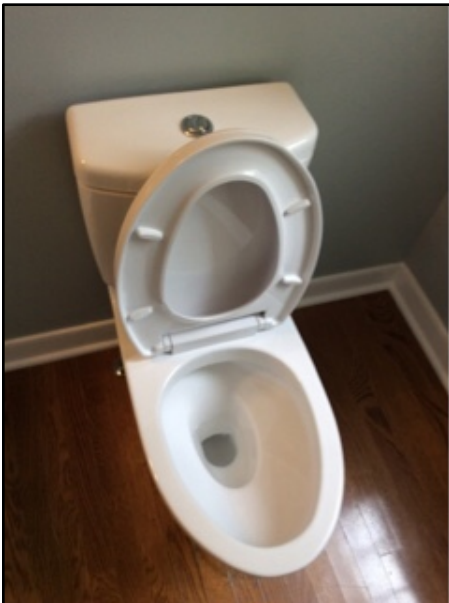
Figure 16-1

Comment 16:
Toilet bowl is loose. Recommend repair.

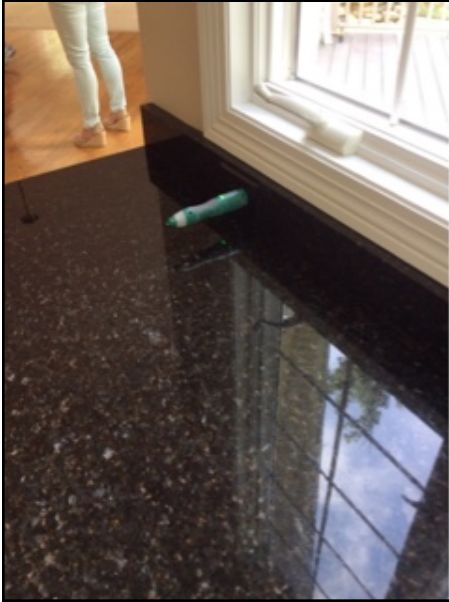
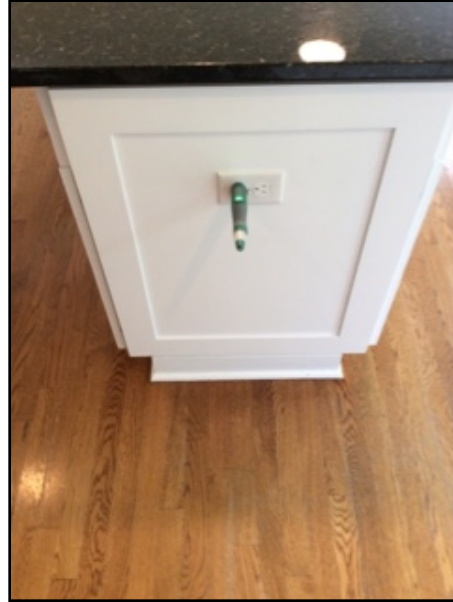
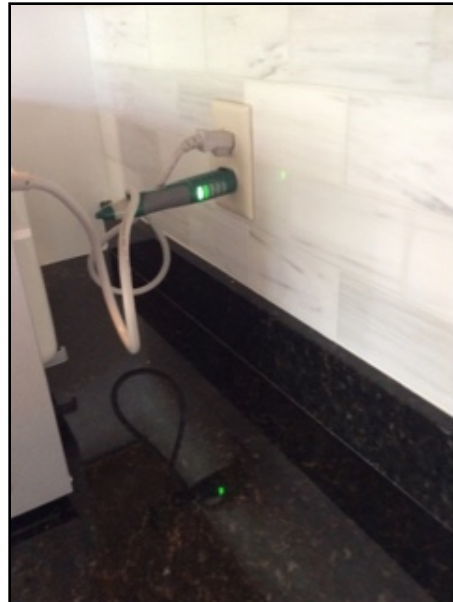
**Comment 17:**
Grounded outlet at kitchen counter tops. Safety Hazard. Recommend repair.
Recommend upgrading to GFCI protected outlet.

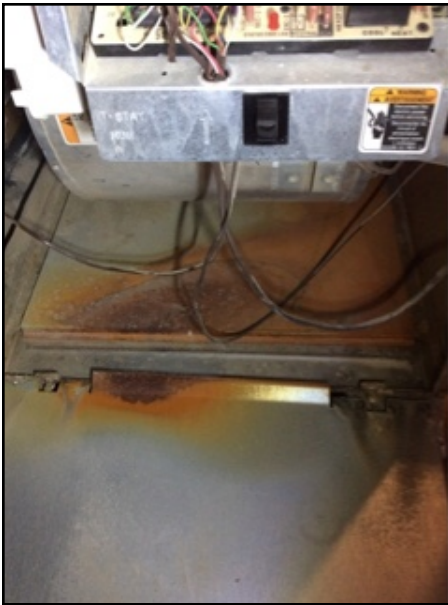
Figure 24-1

Excessive rust present inside furnace. Recommend HVAC service and repairs as needed.

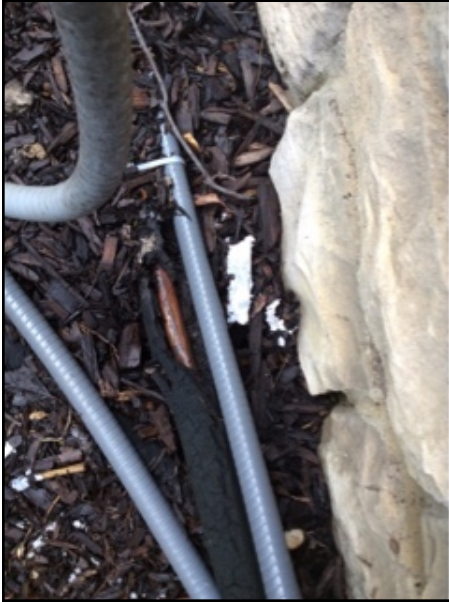
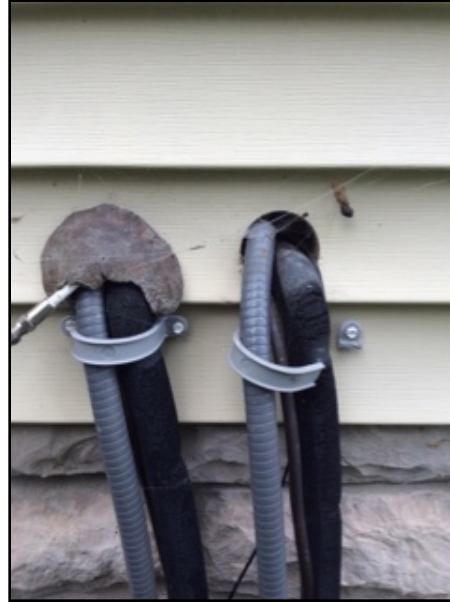
Refrigerant line needs sealed at house penetration. Recommend repair. Insulation at refrigerant lines needs repaired or replaced.

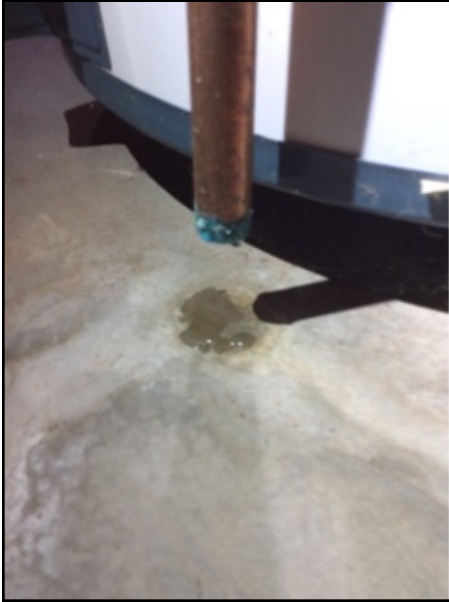
Figure 30-1

Dripping present at water heater pressure relief valve extension. Recommend monitor and replace as needed.

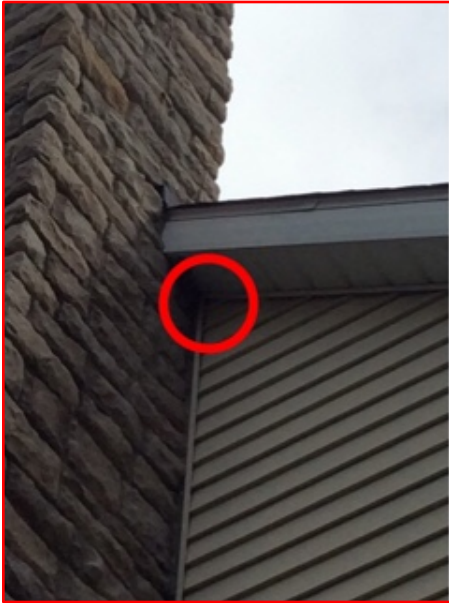
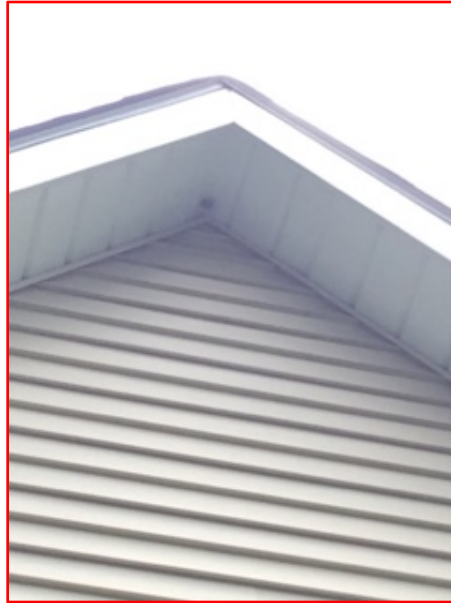
1) Insect nest present near chimney chase. Recommend removal.

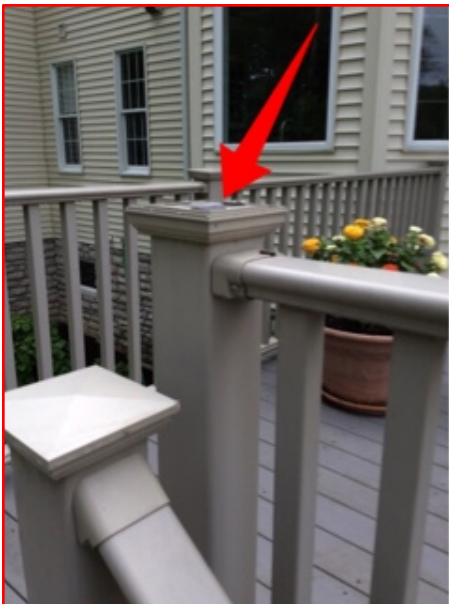
Figure 2-1

2) Missing cap for handrail post. Recommend repair.

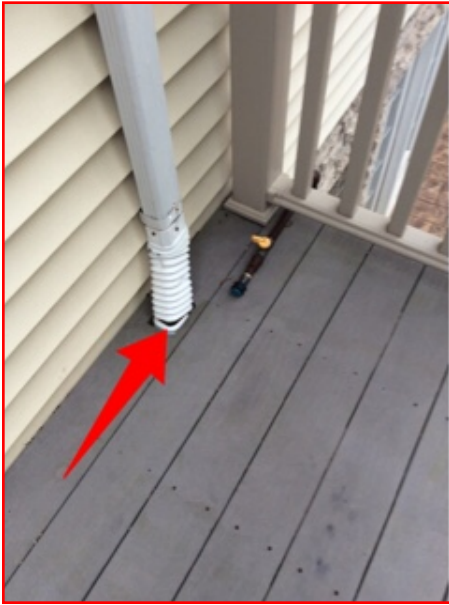
Figure 3-1

3) Damaged piece at rear gutter. Recommend repair.

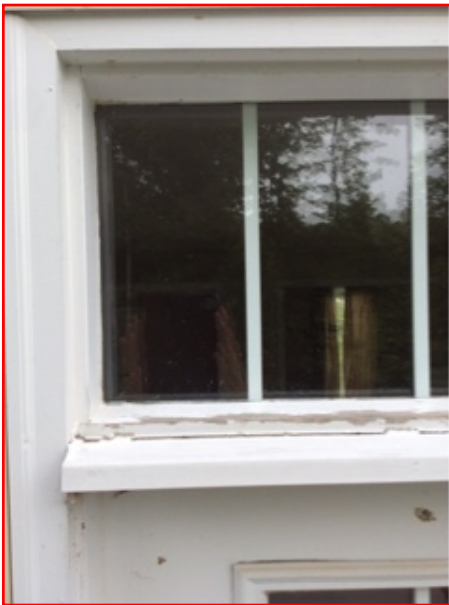
Figure 4-1

4) Wood trim needs paint. Recommend repair.

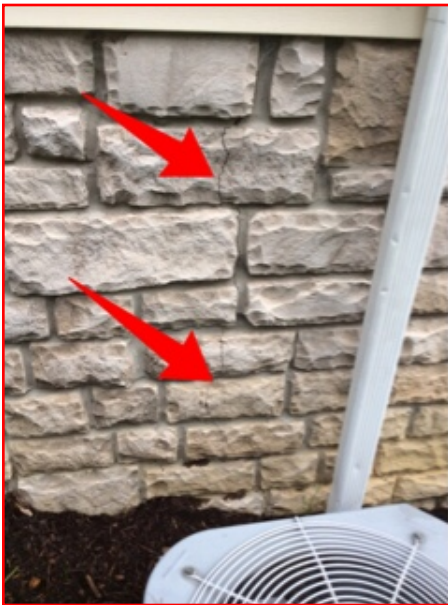
Figure 6-1

6) Recommend sealing settling crack. Recommend repair.

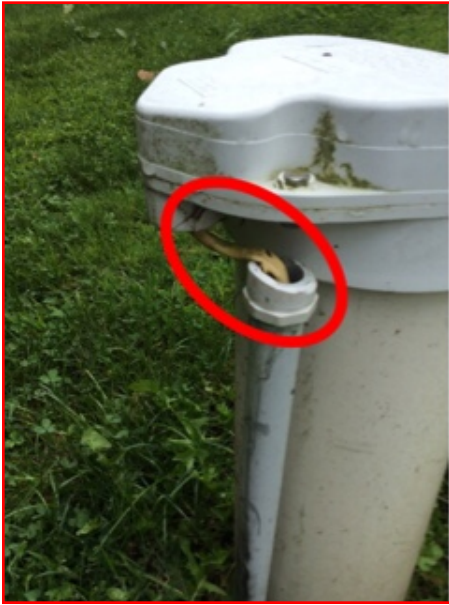
Figure 7-1

7) Conduit and wire at well head were damaged. Recommend repair.

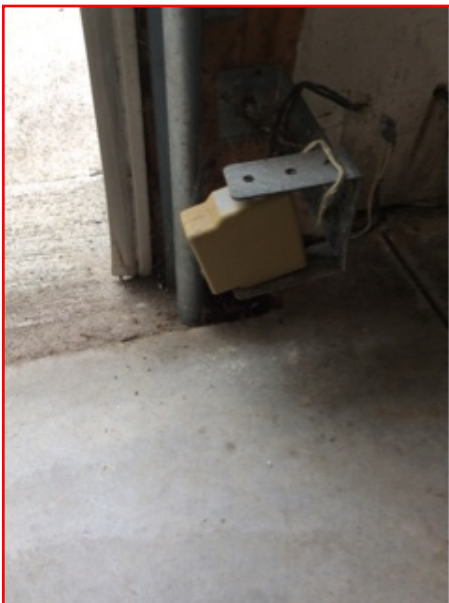
Figure 8-1

8) Garage door was not shutting properly with button. Button had to be held down to shut door. Recommend repair.

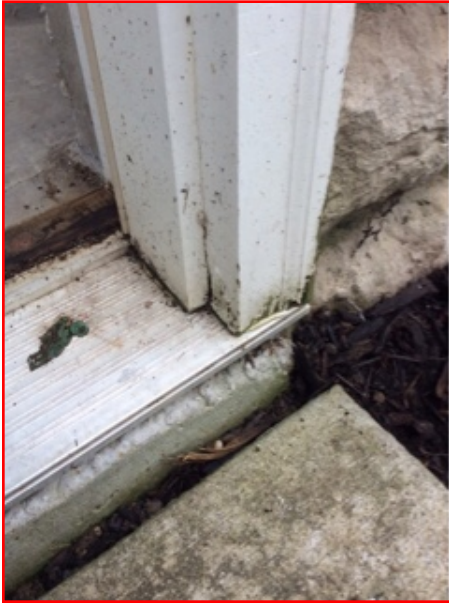
Figure 9-1

9) Wood trim at garage is rotted. Recommend repair.

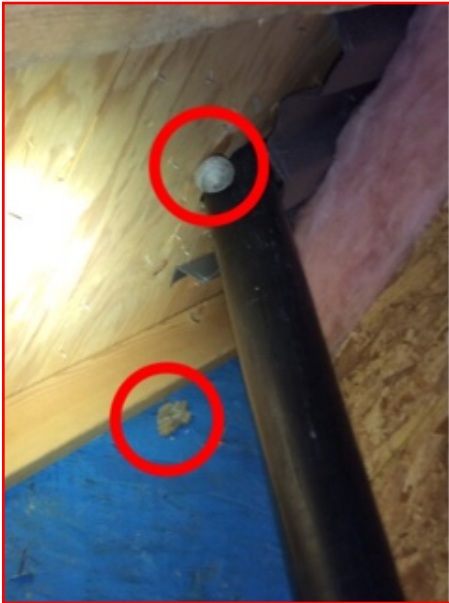
Figure 10-1

10) Old insect nests in attic space. Recommend routine pest management.

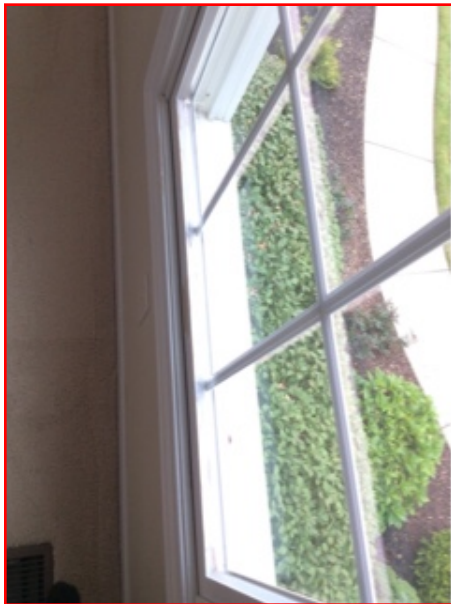
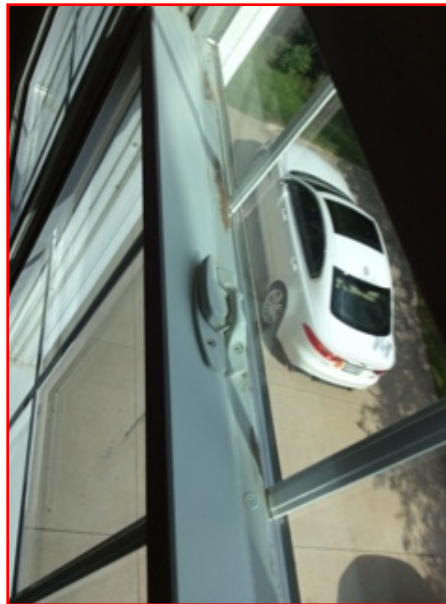
11) Flaking paint at multiple wooden window frames. Not all instances pictured. Recommend repair.

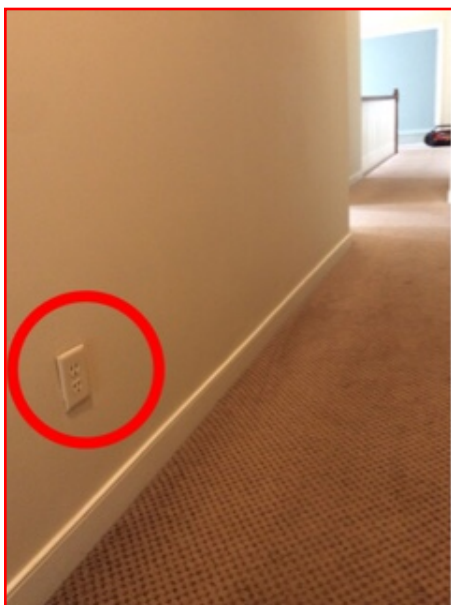
Figure 12-1

12) Several loose electrical outlets throughout the house. Safety Hazard. Recommend repair.

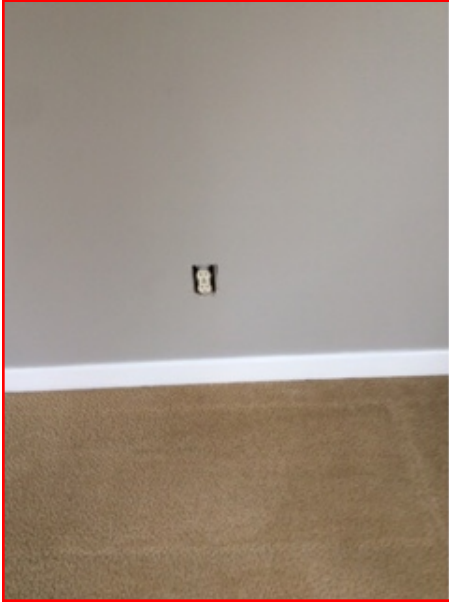
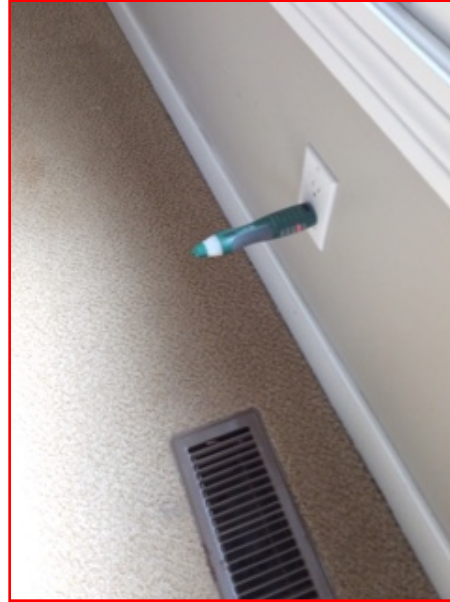
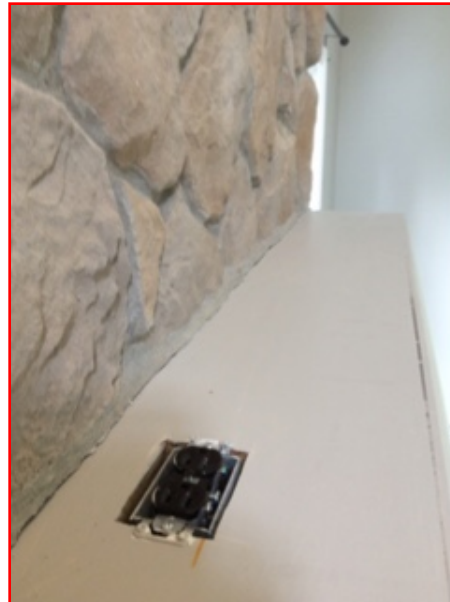
13) Missing outlet cover. Ungrounded outlet. Hot/neutral reversal. Safety hazard. Recommend repair.

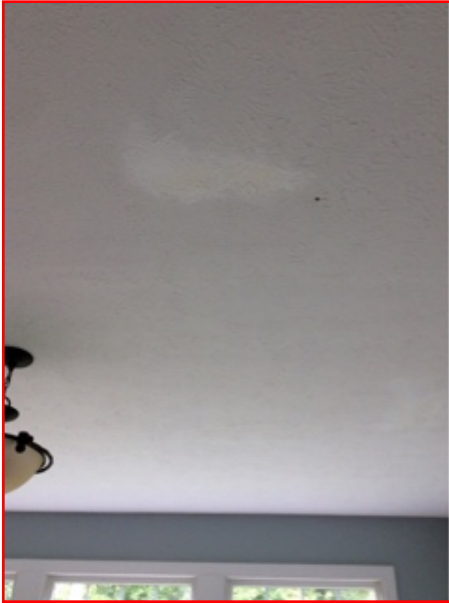
Figure 14-1

14) For Information: Previous repairs at ceiling.

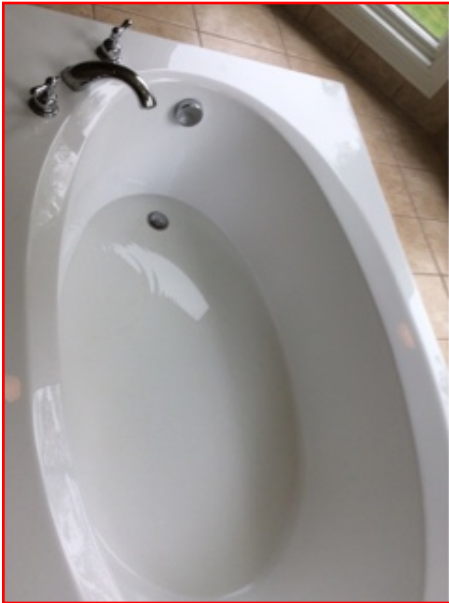
Figure 15-1

15) Slow drain at bathtub. Recommend repair.

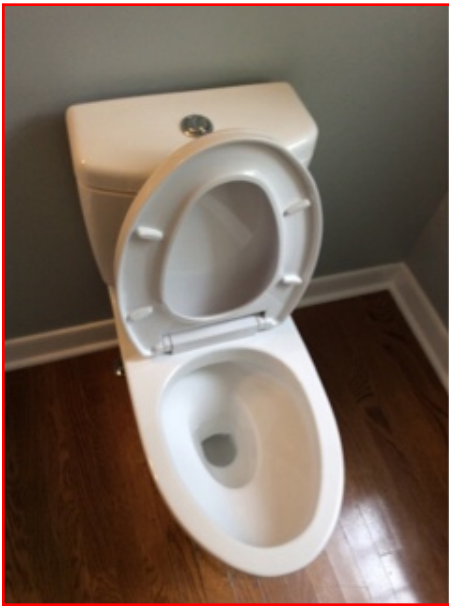
Figure 16-1

16) Toilet bowl is loose. Recommend repair.

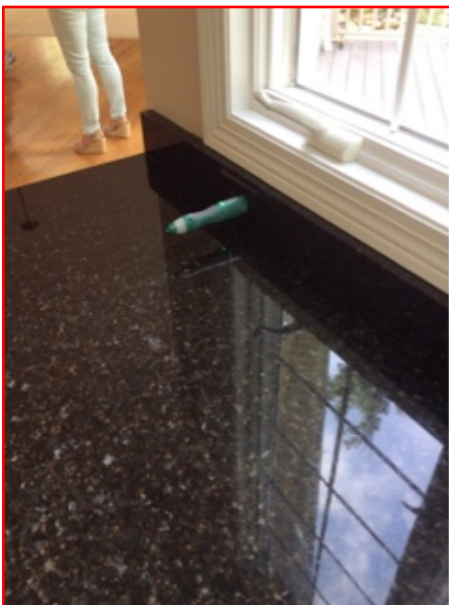
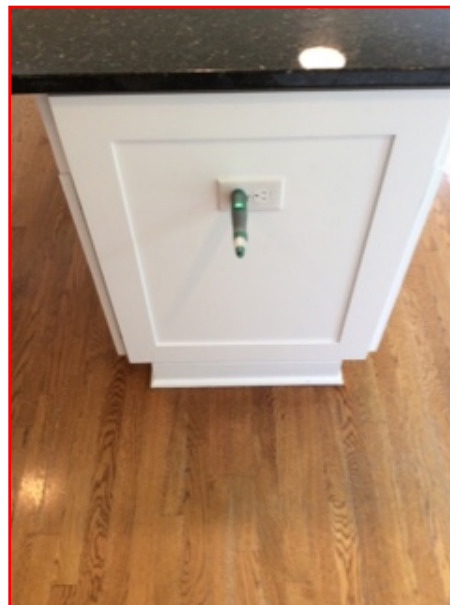
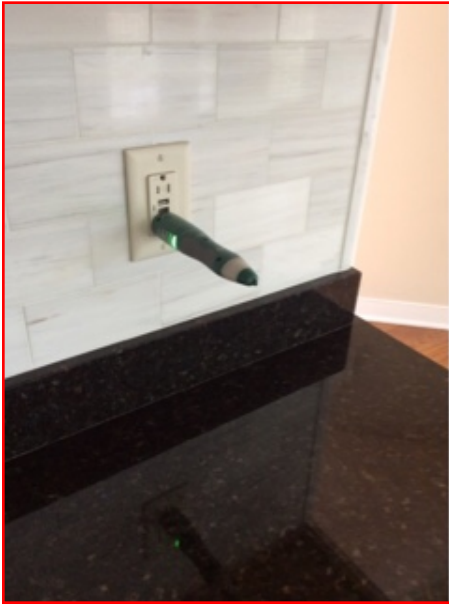
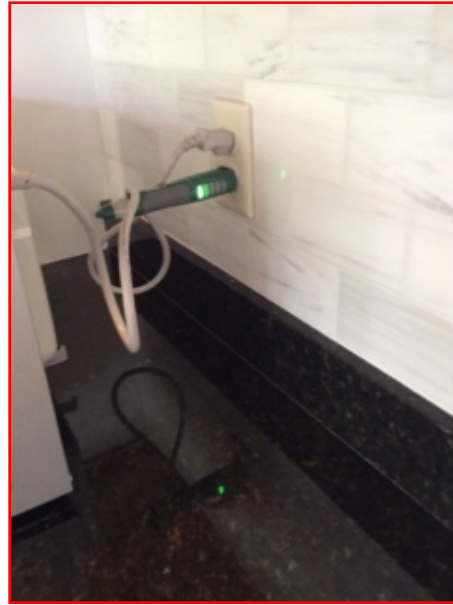
17) Grounded outlet at kitchen counter tops. Safety Hazard. Recommend repair. Recommend upgrading to GFCI protected outlet.

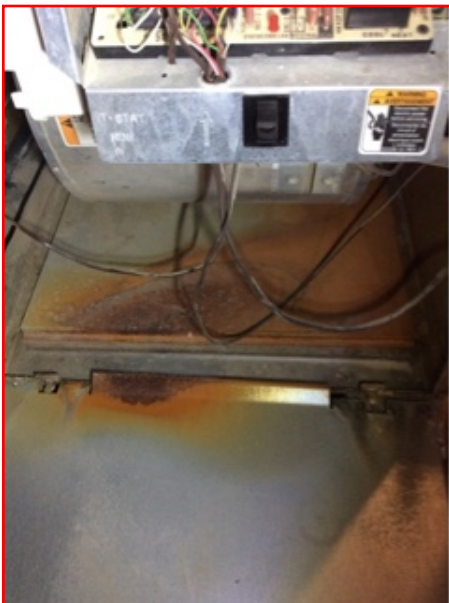
Figure 24-1

18) Excessive rust present inside furnace. Recommend HVAC service and repairs as needed.

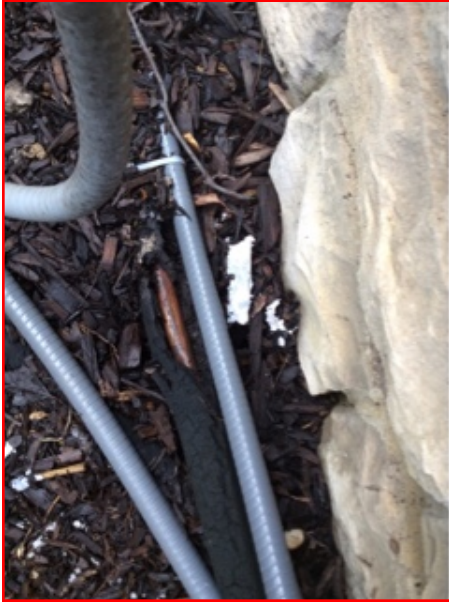
Figure 27-1

19) Refrigerant line needs sealed at house penetration. Recommend repair. Insulation at refrigerant lines needs repaired or replaced.

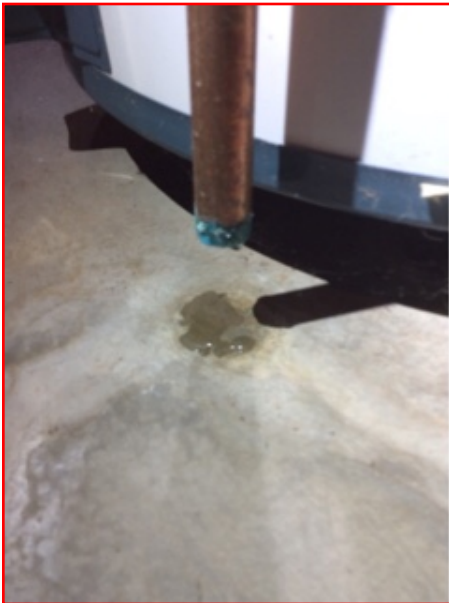
Figure 30-1

20) Dripping present at water heater pressure relief valve extension. Recommend monitor and replace as needed.
