FlashSeal[™]

The Solution for Deteriorated Flashings Around Chimneys, Stack, and Vents

ELASTOMERIC FLASHING SEALANT

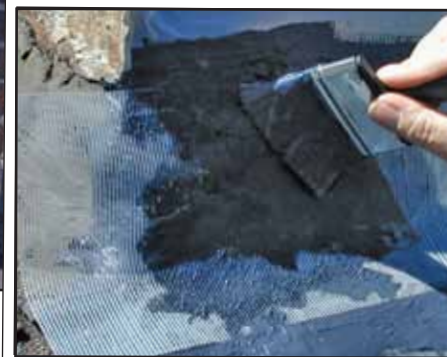
For added strength and flexibility, a fiberglass fabric is embedded between 2 coats of FlashSeal Elastomeric Sealant

FlashSeal Elastomeric Sealant is available in one gallon containers and is used in conjunction with FlashSeal Reinforcement Fabric sold separately in 150 ft. rolls. One roll of Reinforcement Fabric will last through 3 - 4 gallons of FlashSeal.

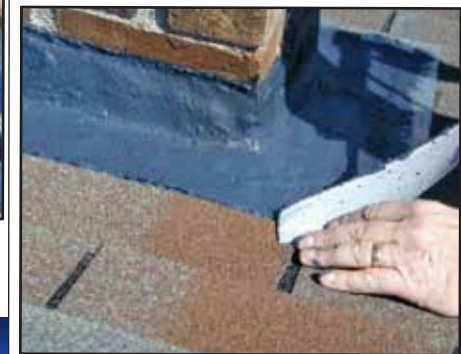
In most cases the roof deck and chimney are taped off to produce a neat appearance of the finished application
