Inspection Tech Home Inspection Report

Mr. & Mrs. Client

1234 Example Dr.

Inspected on Tue, Oct 2 2018 at 10:44 AM

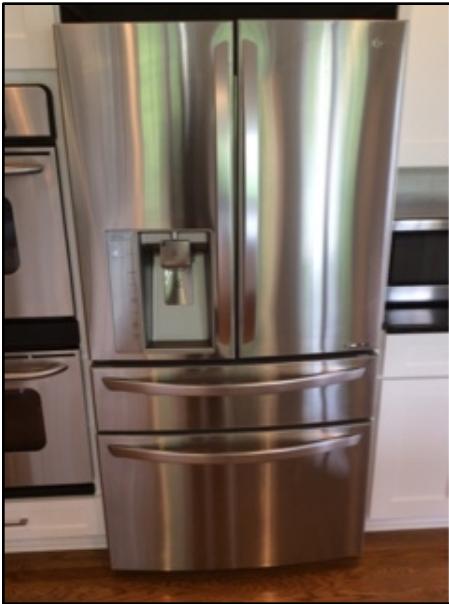
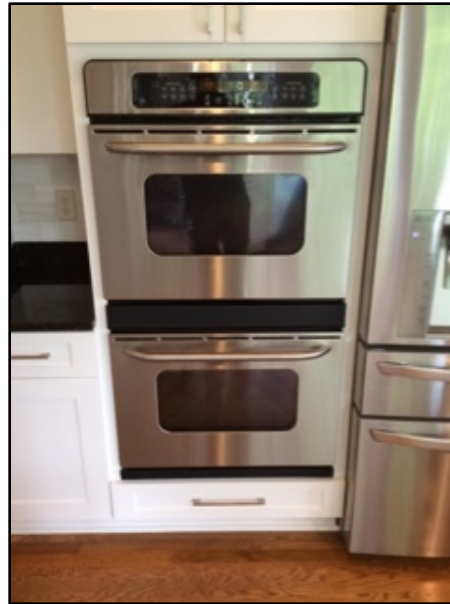
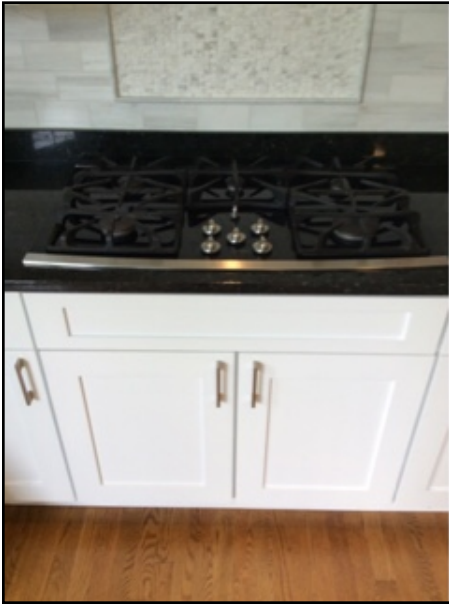
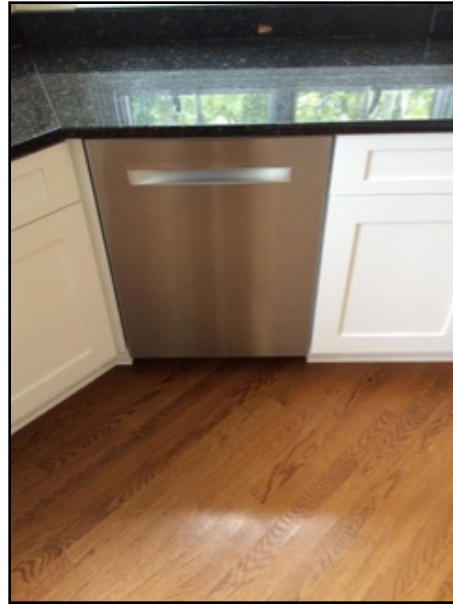
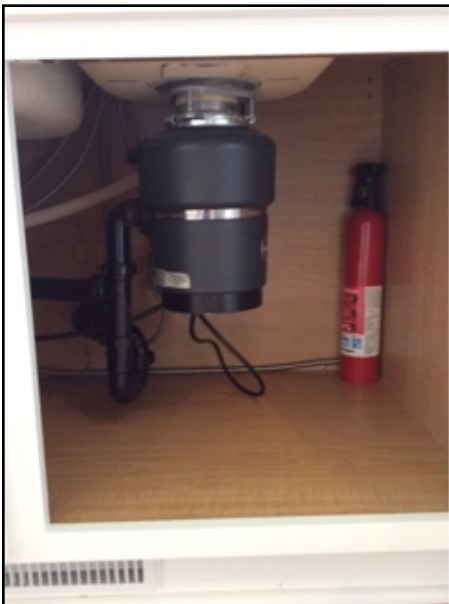
For Information: Appliances present at the time of inspection.

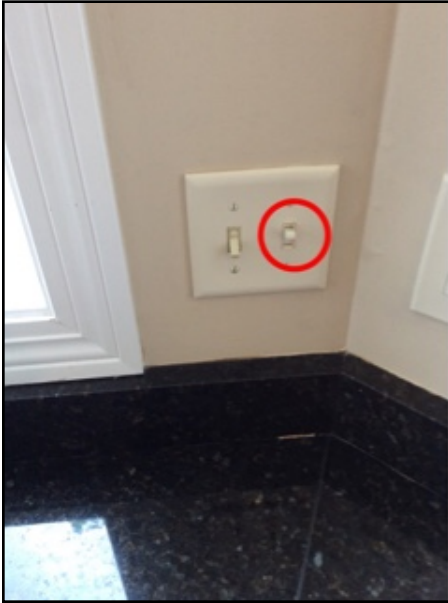
Figure 19-1

For Information: Dishwasher is controlled with switch.

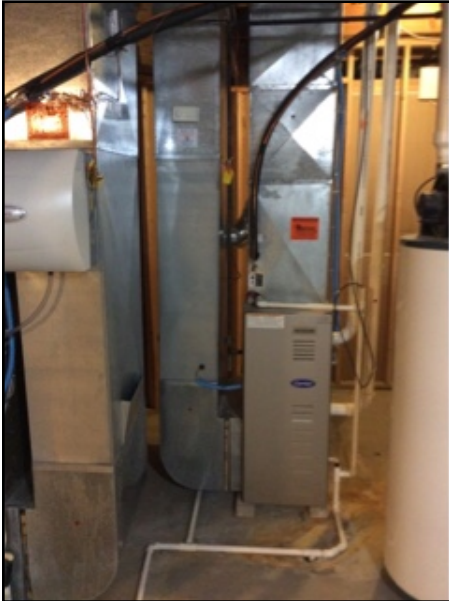
Comment 21:
For Information: Furnaces.

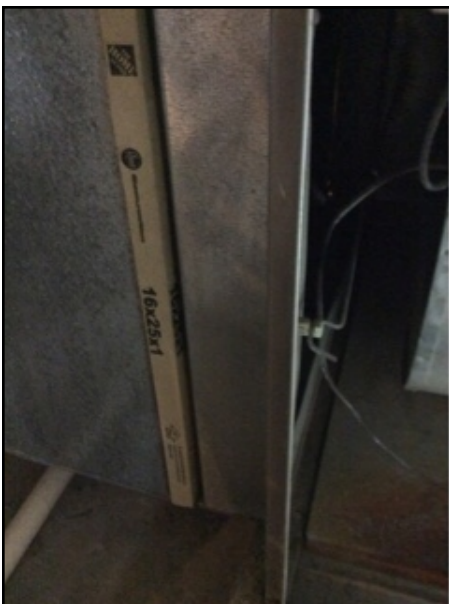
Figure 22-1

Comment 22:
For Information: Air filter size.

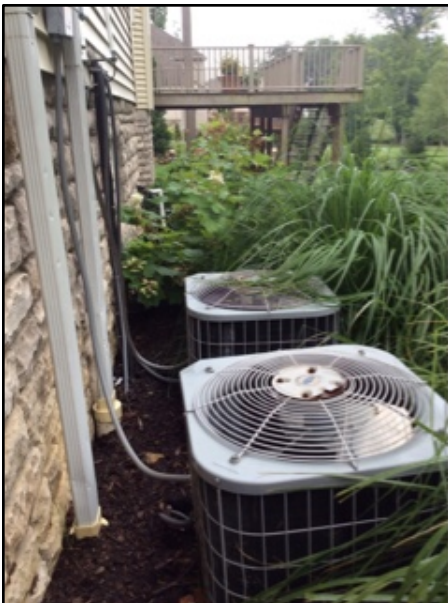
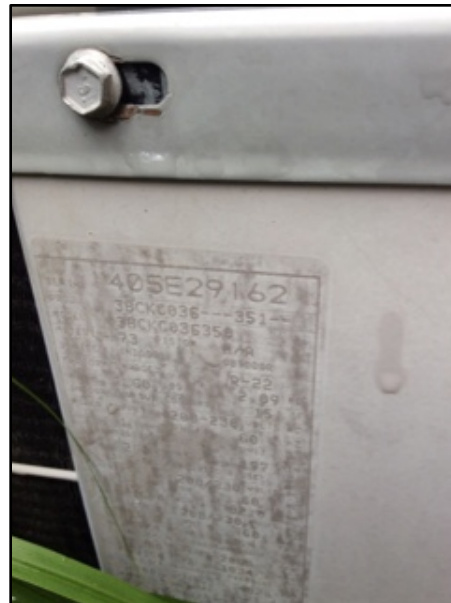
For Information: A/C Unit.

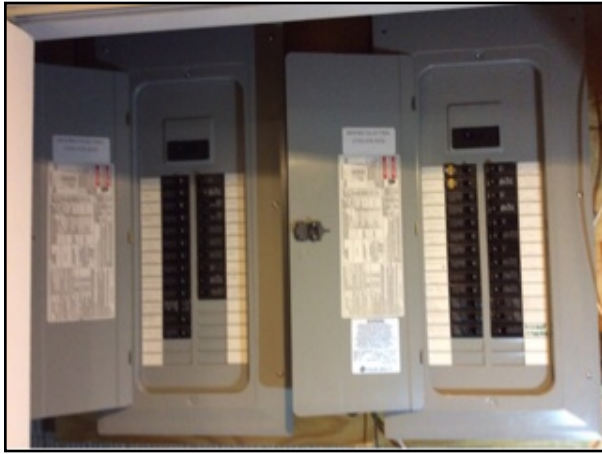
Comment 28:
For Information: Electrical Panel(s).

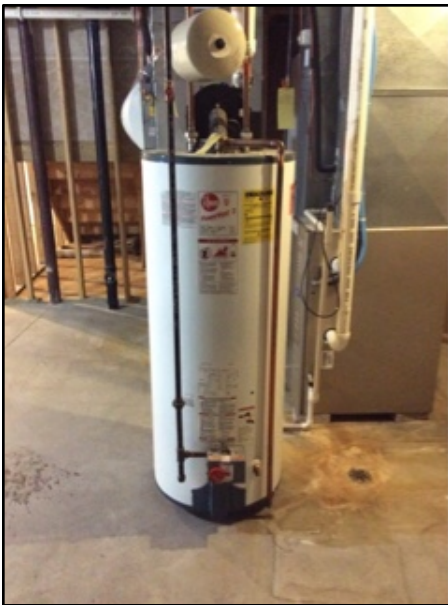
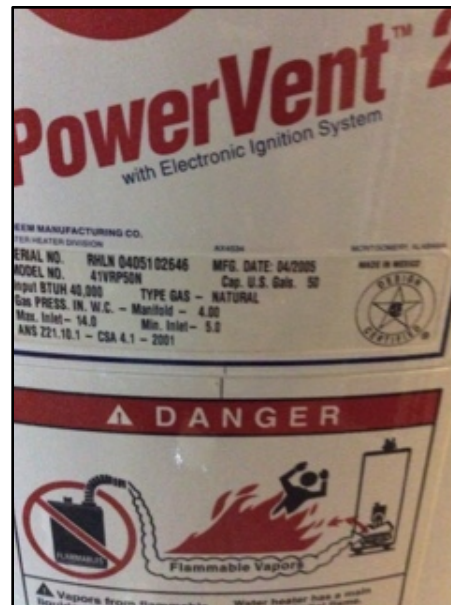
Comment 29:
For Information: Water heater.

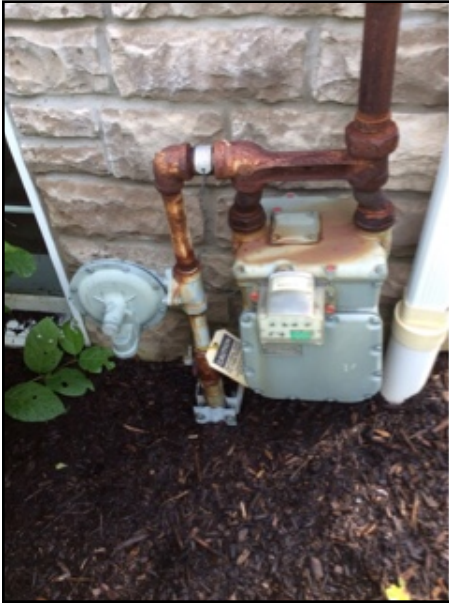
Figure 31-1

For Information: Main gas shutoff.

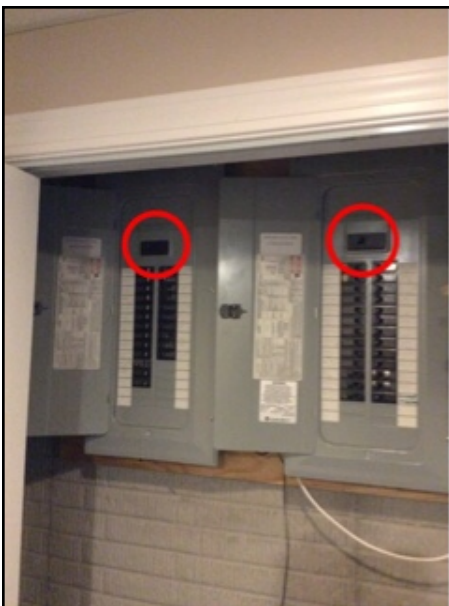
Figure 32-1

For Information: Main electrical shutoff.

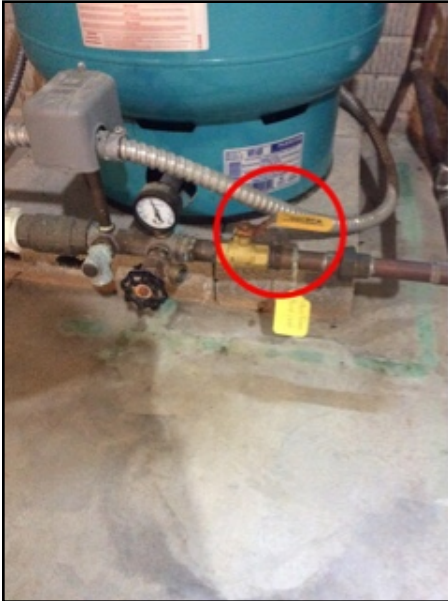
Figure 33-1

For Information: Main water shutoff.
